west virginia department of environmental remediation  
Office of Environmental Remediation

VRP Project #: **15017**  
Brownfield Site: Yes ☐ No ☒  
Report Date: **3-22-16**  
Page **1** of **4**

**OFFICE OF ENVIRONMENTAL REMEDIATION**  
**VOLUNTARY REMEDIATION PROJECT**  
**SITE VISIT/INSPECTION REPORT**

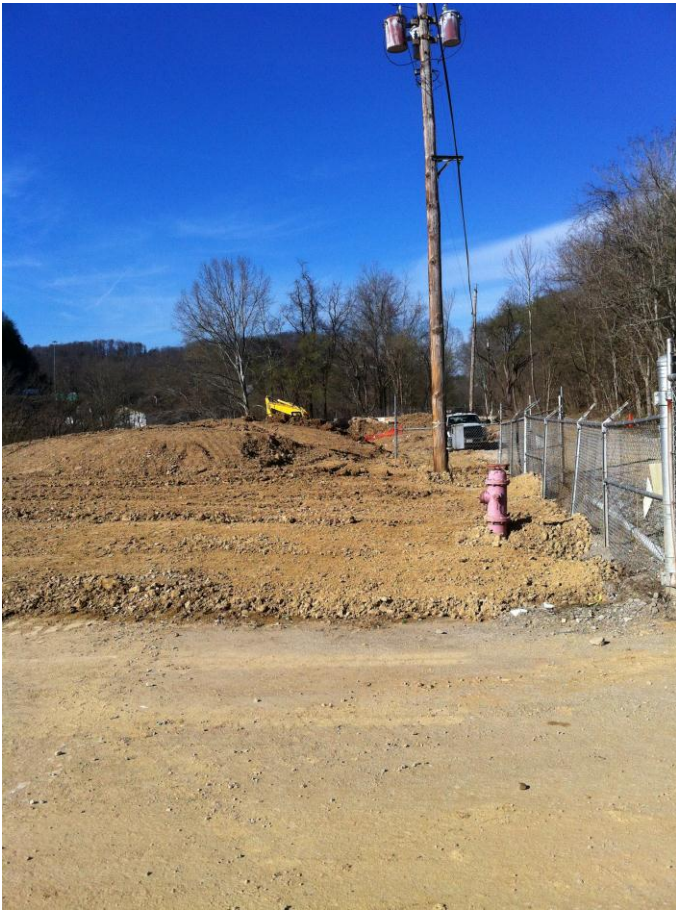
1. View of surplus soil pile leftover from slope grading, just south of top of slope - looking north.
2. Compacting #10 stone in french drain system on slope.
3. #10 stone in "half-moon" trench at top of slope.

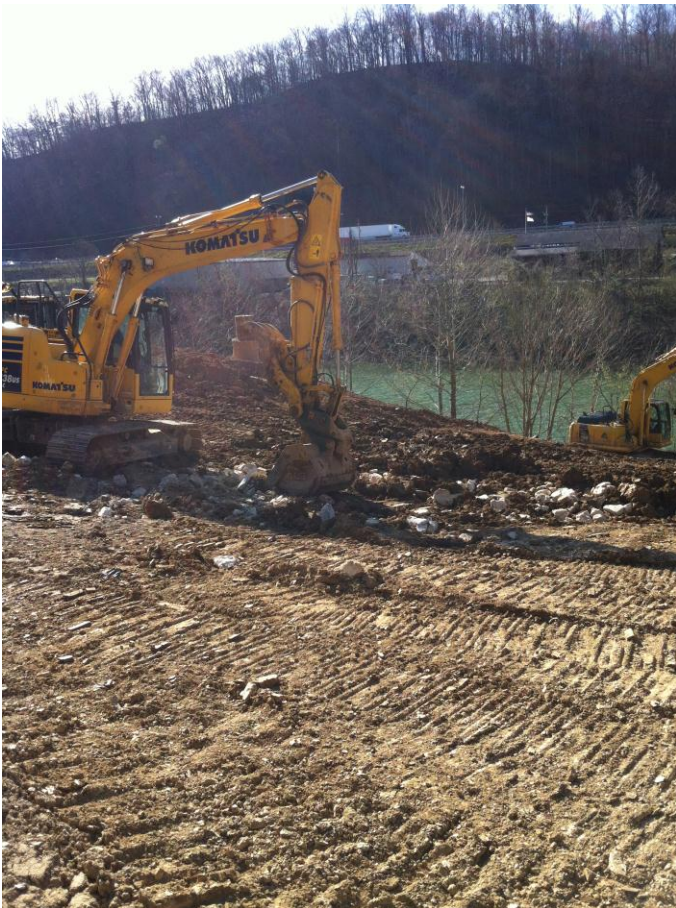
2.

Primary goal today was installation of the french drain system at the toe of the slope and up into the slope itself. KInder explained the construction of the french drain system. A wide (10-12') trench was installed from the toe of the slope up through the middle of the slope area (perpendicular to the collection trench on the lower level) where groundwater discharge was obviously occurring. This led to a trench installed perpendicular to the slope about halfway up (midslope) - this trench was ~ 10-12' deep.. From there, "fingers" were installed in a fan shape further upslope and laterally to the areas where groundwater seeps were evident. A "half-moon" trench was then installed at the top of the "fingers" (essentially at the top of the slope) where groundwater seeps were evident. A large retention trench was installed on the lower level adjacent to and south of the main collection trench - the french drain system tied into this trench. The entire french drain system was filled with #10 stone and will be capped with clay. Additional clay will be trucked in tomorrow.

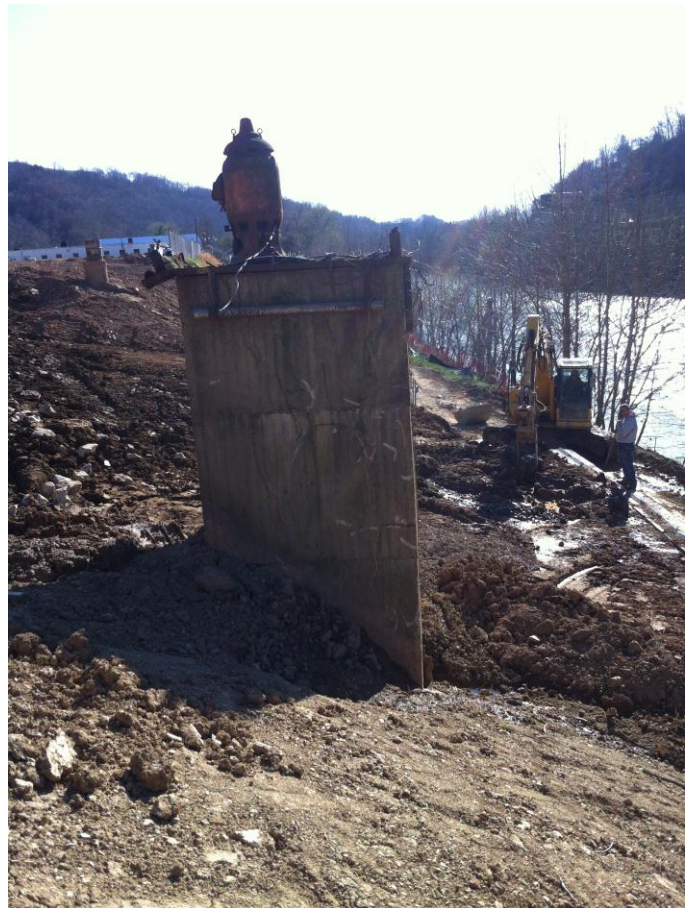
4. French drain installation at toe of slope, just above concrete buttress - looking south.
5. Area of retention trench adjacent to and south of main collection trench.
